Bishopbriggs War Memorial Hall

Existing Interior Bishopbriggs War Memorial Hall

Proposed Plan Bishopbriggs War Memorial Hall

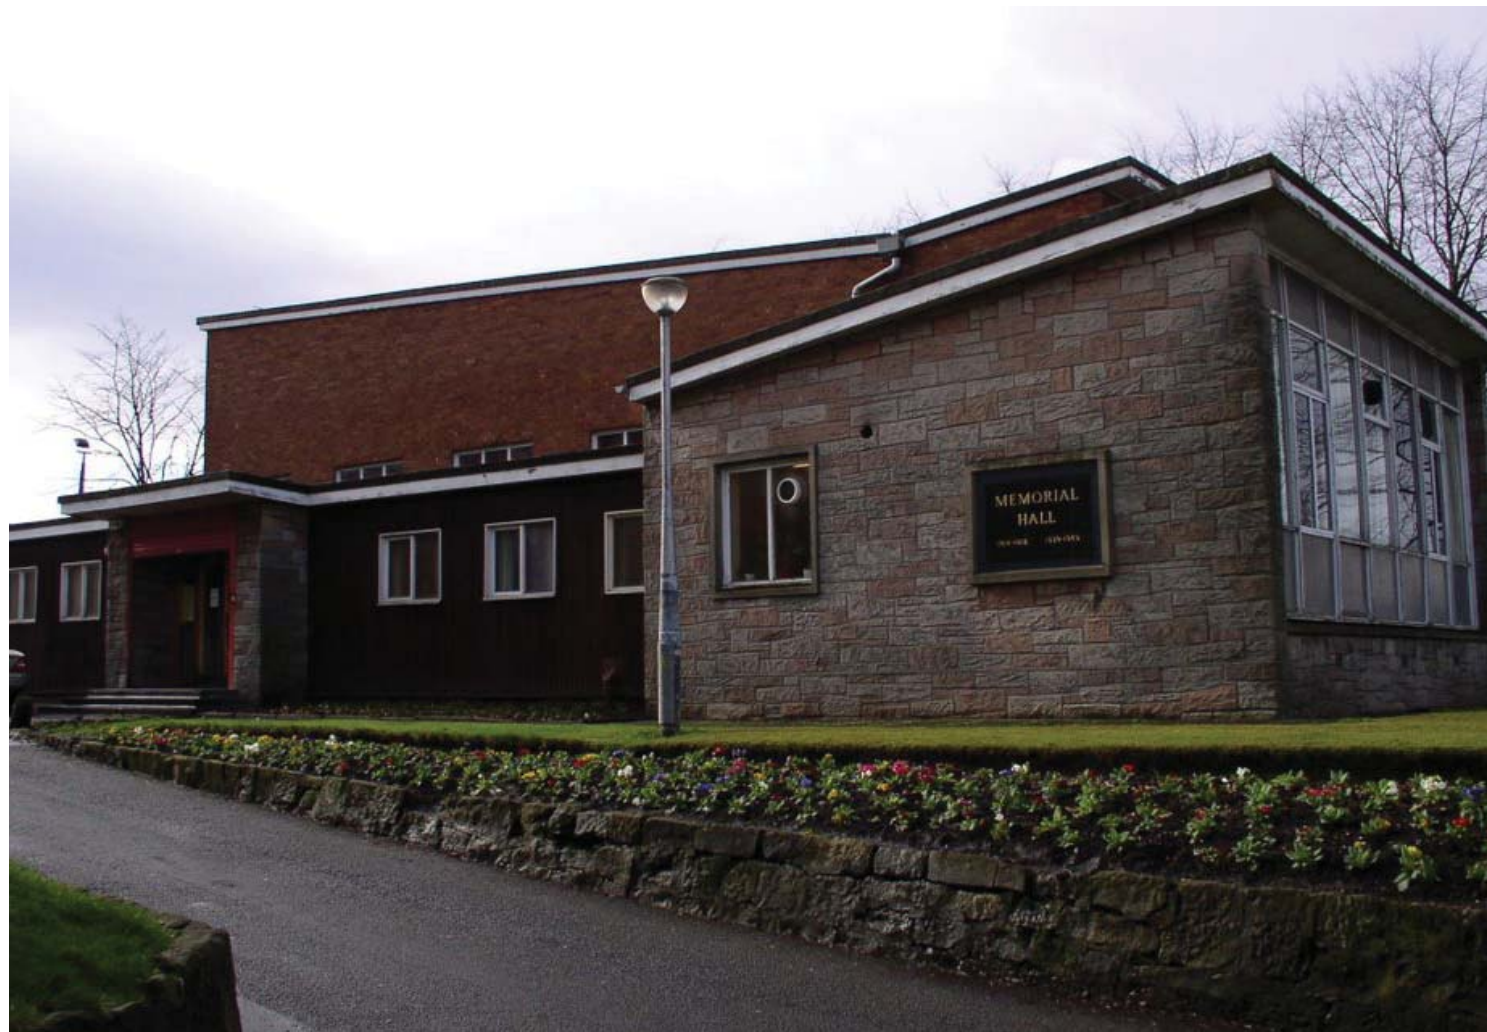
Caretaker's office is remote and isolated

Kitchen lacks connection to hall

Building is not sufficiently accessible

Stage is not often utilised

Storage under stage is unsafe to access

Lack of flexible space

Functions in the Hall can be very noisy

Sanitary facilities do not meet current requirements

Road access to the building is in poor condition

Opportunity to relocate to allow visible presence at main entrance for improved supervision

Potential to relocate kitchen to offer direct service to main hall

Doorways should be widened and hallway can open up to allow convenient flow of movement to accessible WC. Lesser hall may be brought to grade with rest of building for level access.

Stage can be removed to provide more flexible floor space in the hall.

A new level store room can provide adequate, safe, efficient storage with direct access to the hall

There is the potential to expand the lesser hall with a new dividing wall to allow for flexibility of use

Building fabric can be improved to minimise excessive noise leakage as well as the retention of the existing noise limiting system

Number of WCs to be maximised within the available space.

The existing road access could be repaired and improved, as well as new line markings to the parking areas.

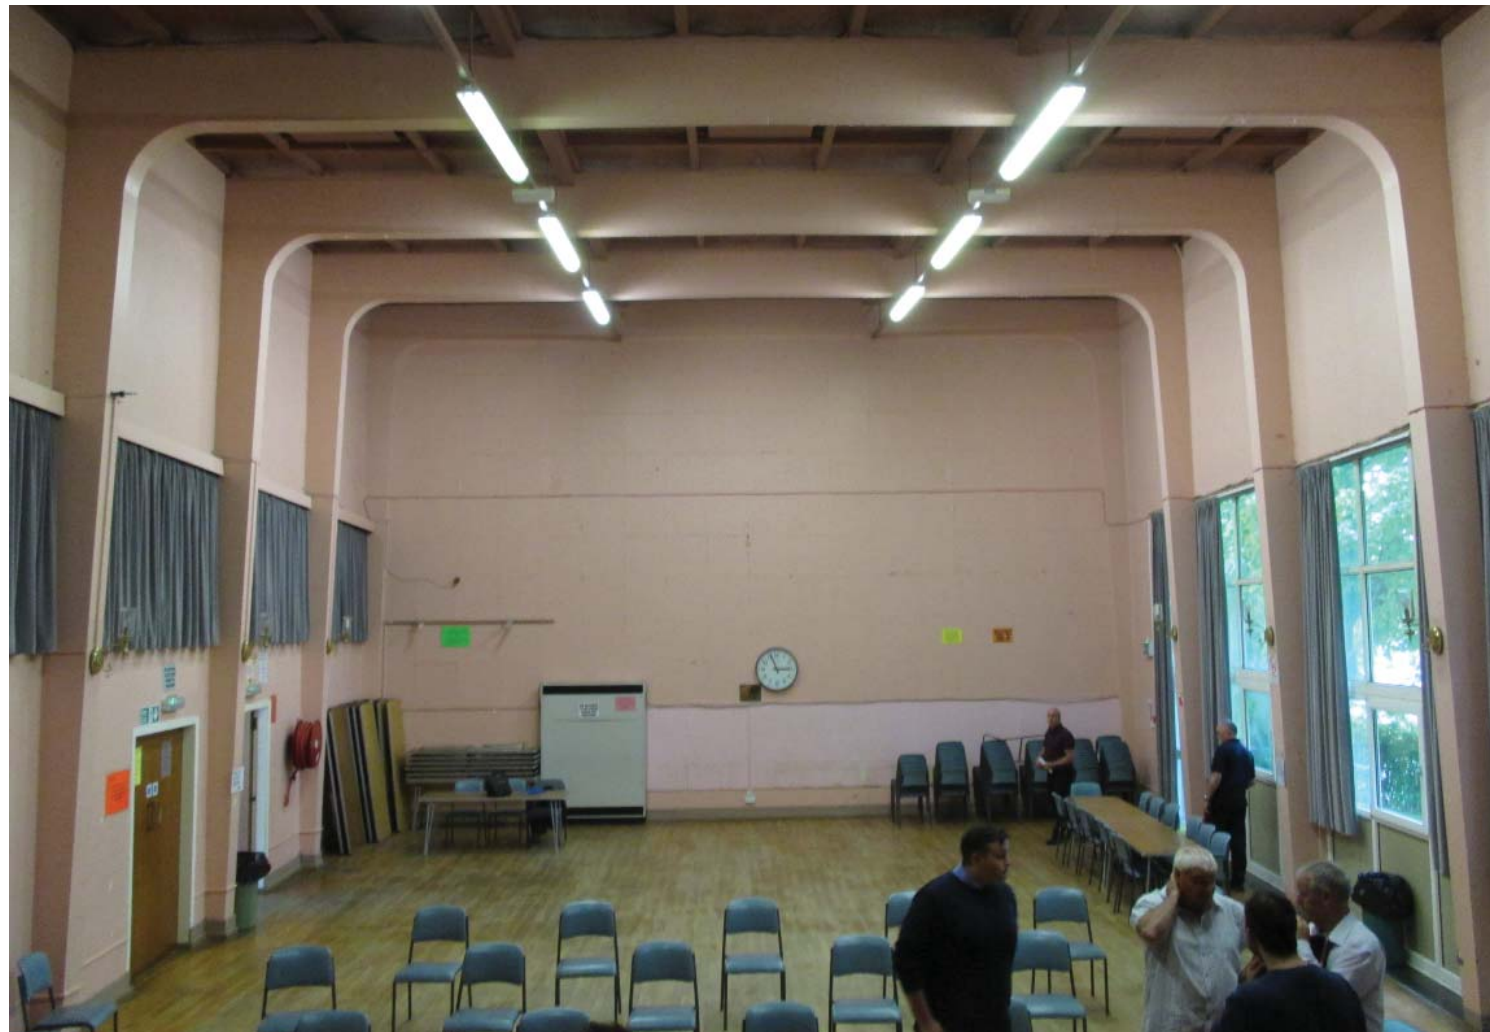
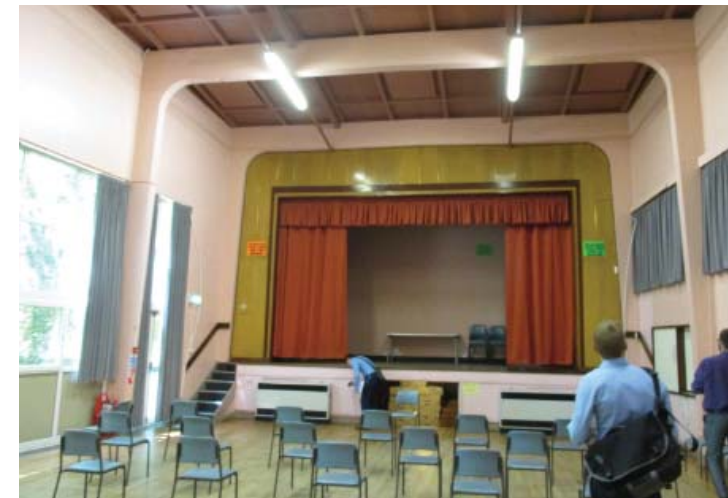
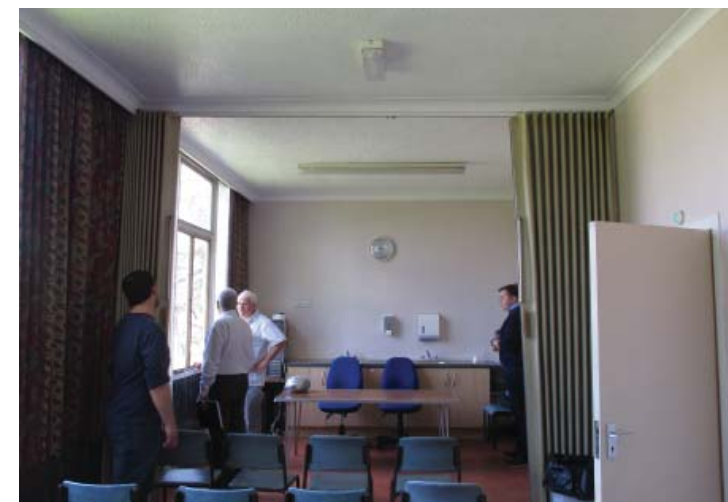
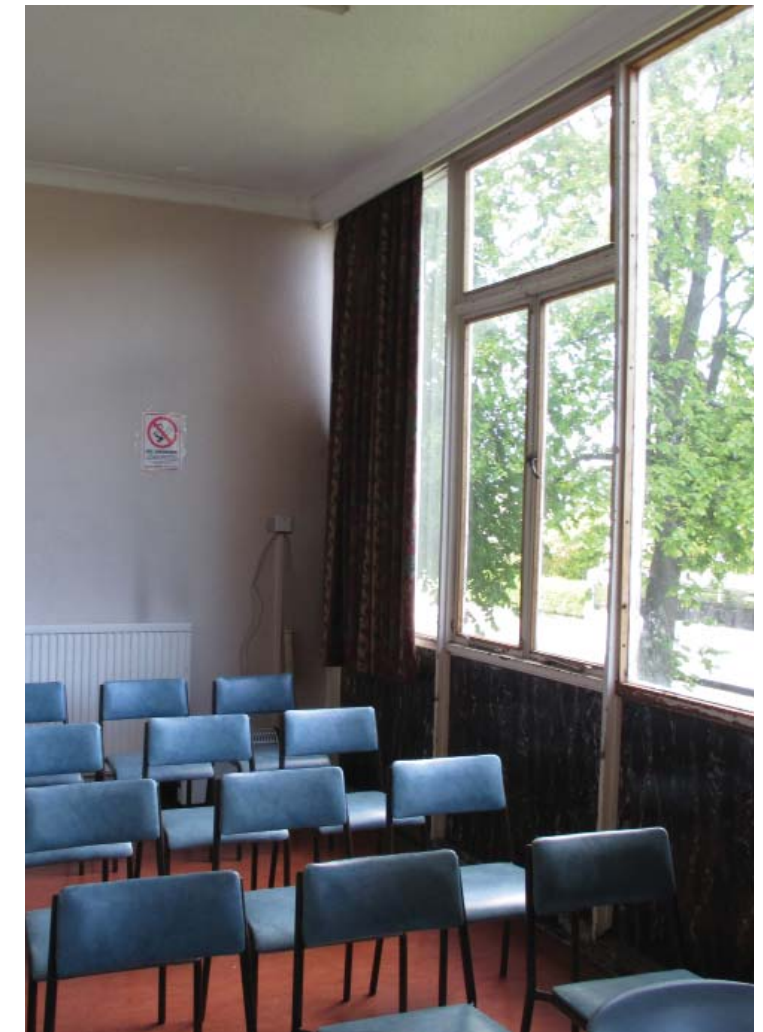
The two existing halls are a good size and well used although now very dated. The stage is not frequently used. The divider in the lesser hall is not fit for purpose.

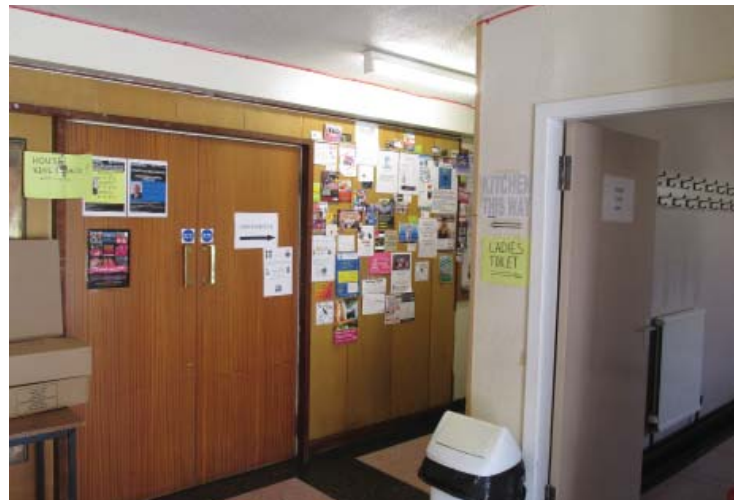
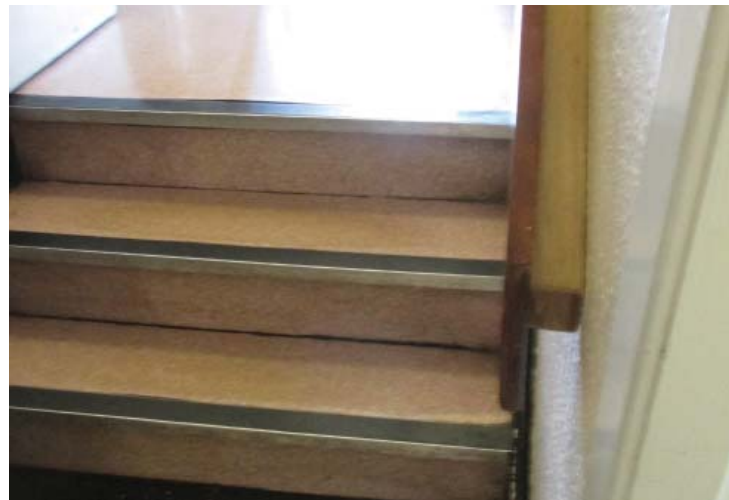
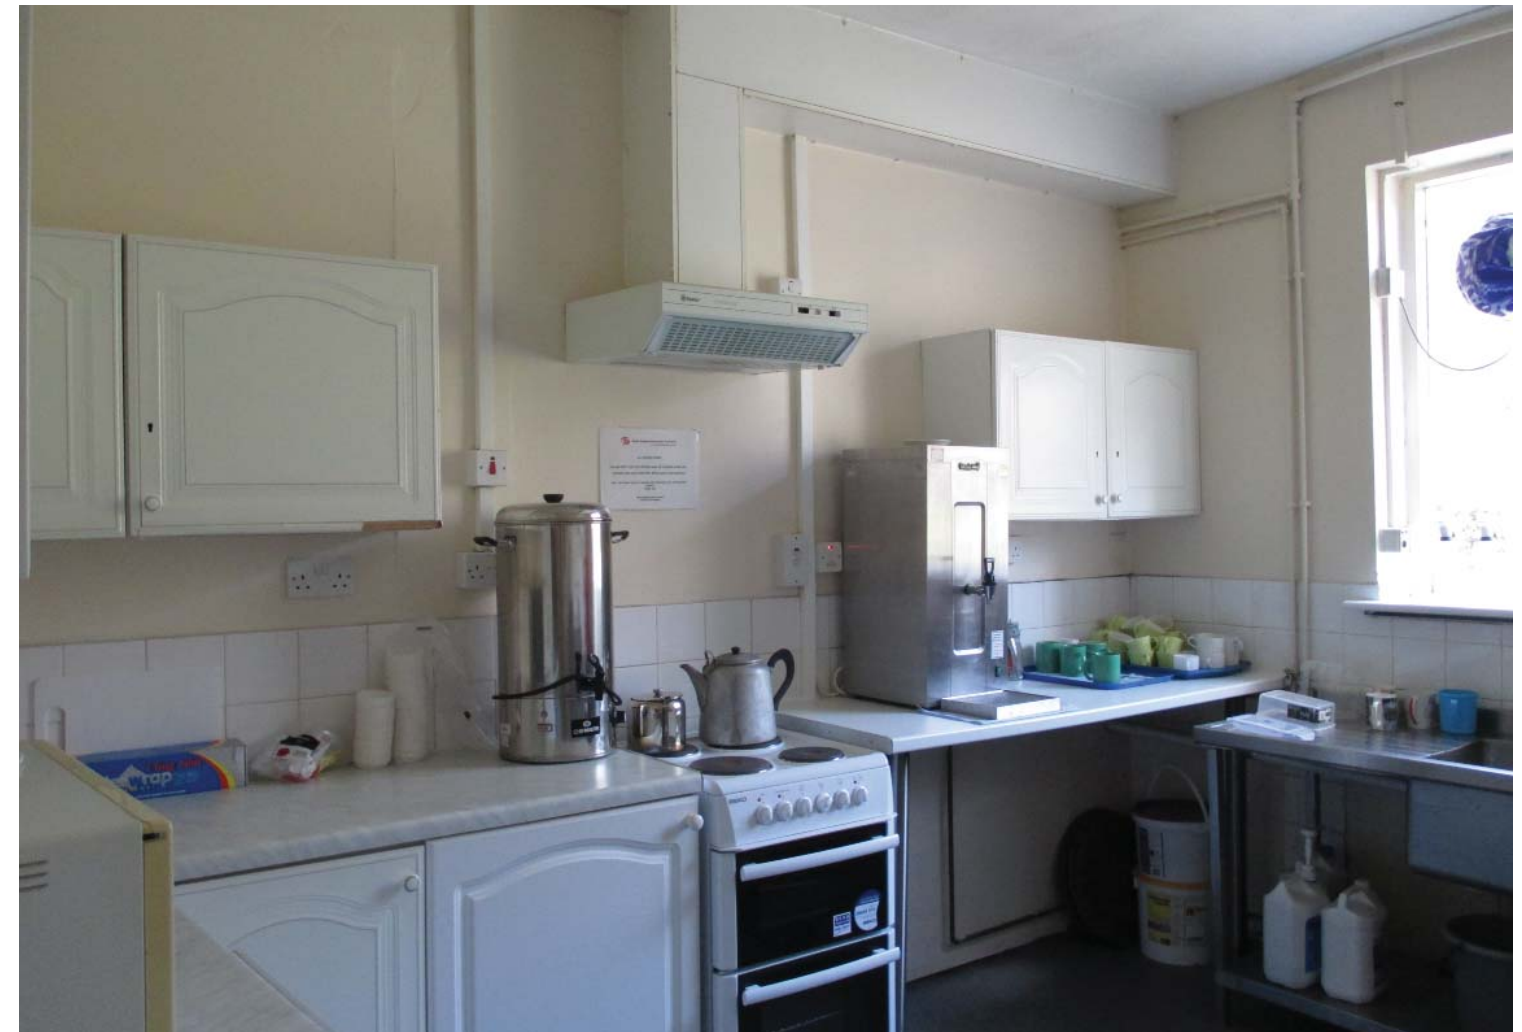
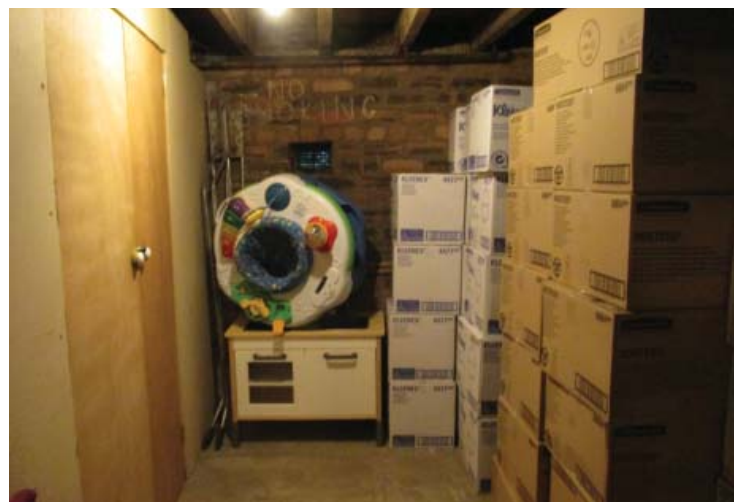
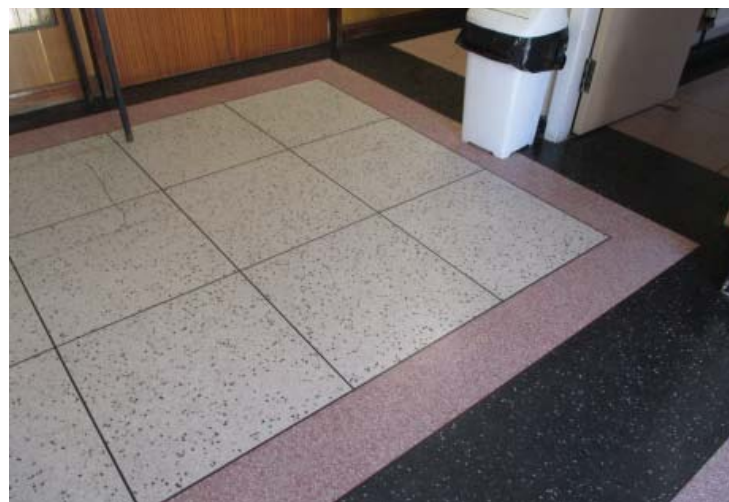
The ancillary spaces are dated; modernisation is required throughout. The current storage space underneath the stage is hazardous to use. The steps towards the lesser hall make this more difficult to access. The existing terrazzo flooring is of a high quality and is hoped to be retained.
